B-2996 - B-3001

719-737 S. Hanover St. (East side)

INVENTORY FORM FOR STATE HISTORIC SITES SURVEY

719 S. Hanover St.

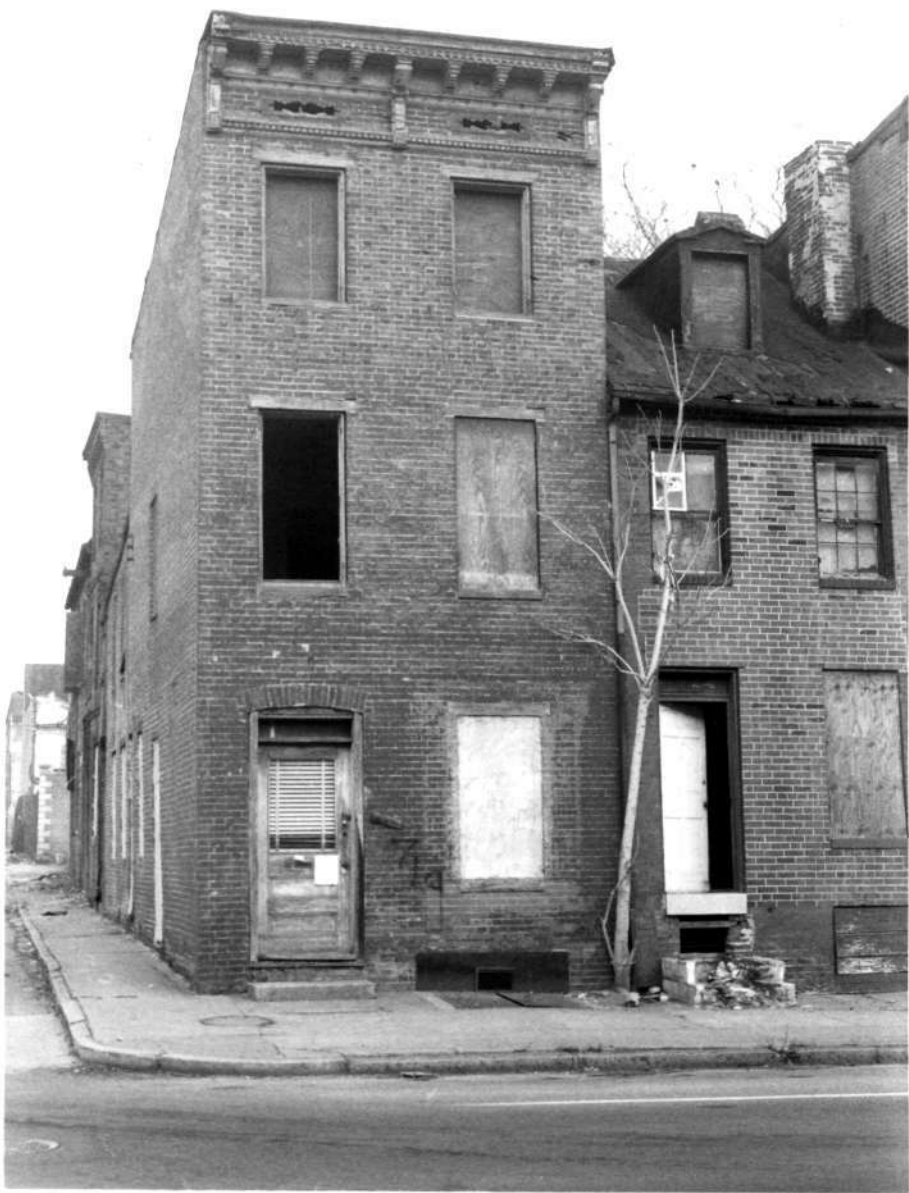
B-2996

This three story high, two bay wide brick structure with a shed roof and Italianate style bracket cornice is an enlargement of an original 2 1/2 story house that was the northernmost member of a row of such houses built on this site in the late 1830's. The facade still shows the Flemish bond brickwork of its 2 1/2 story neighbors and the different character of the brickwork used for the third story is obvious.

West elevation
